**Flood Control Project Maintenance  
Levee Inspections**

**Fall 2012 Levee Maintenance Deficiency Summary Report**

**Reclamation District No. 2031 Elliot**

**Fall 2012 Levee Inspection Results**

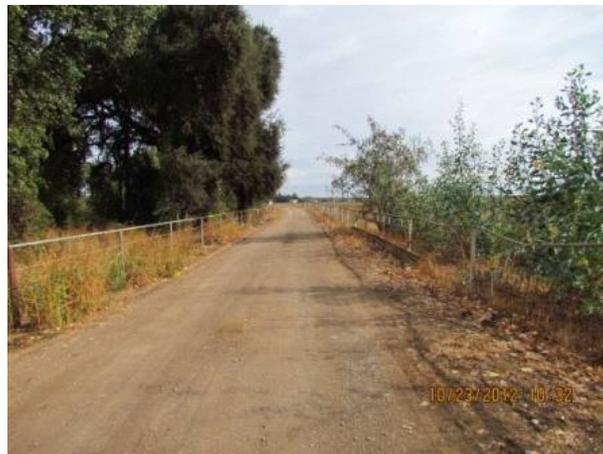
Levee Mile Report Line	6
Start Levee Mile	0.34
End Levee Mile	0.52
Location	Water Side
Category	Earthen Levee
Item	Encroachments
View of fence obstructing access to waterside slope. Facing upstream.	
mkhashch_f_20121029_683.JPG

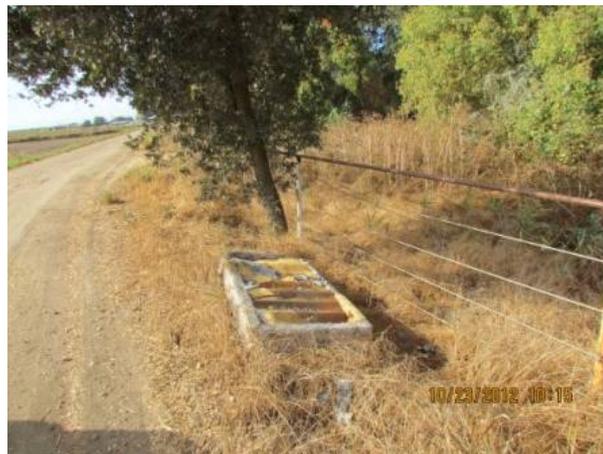
Levee Mile Report Line	7
Start Levee Mile	0.36
End Levee Mile	0.36
Location	Water Side
Category	Earthen Levee
Item	Encroachments
View of garbage on waterside slope obstructing visibility.	
mkhashch_f_20121029_684.JPG

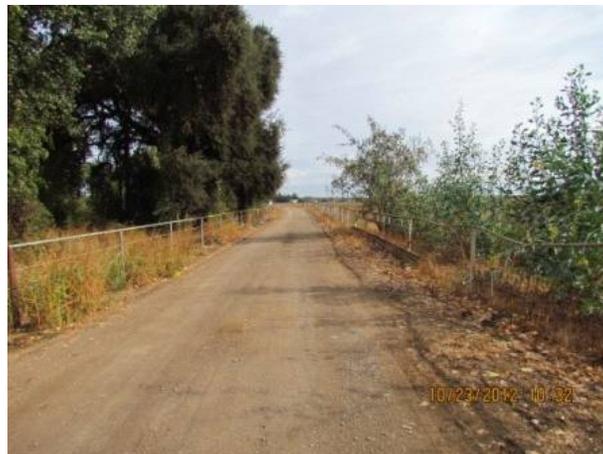
Levee Mile Report Line	8
Start Levee Mile	0.45
End Levee Mile	0.52
Location	Land Side
Category	Earthen Levee
Item	Encroachments
View of fence on landside levee shoulder obstructing access to landside slope. Facing upstream.	
mkhashch_f_20121029_686.JPG

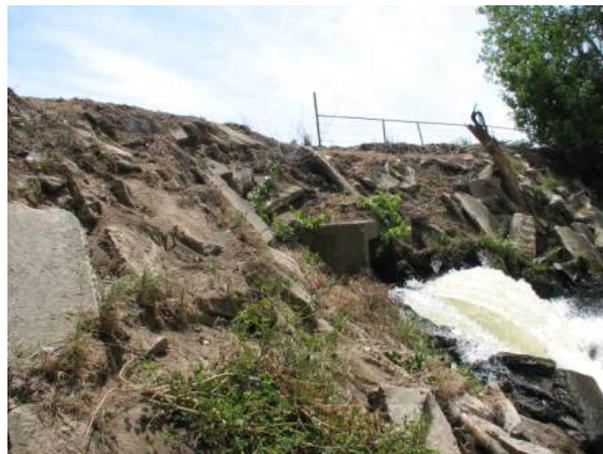
Levee Mile Report Line	9
Start Levee Mile	0.46
End Levee Mile	0.46
Location	Water Side
Category	Interior Drainage & Piping Systems
Item	Flap Gates
View of canal outlet on waterward slope facing downstream. 05/02/2012	
mkhashch_f_20120927_059.jpg

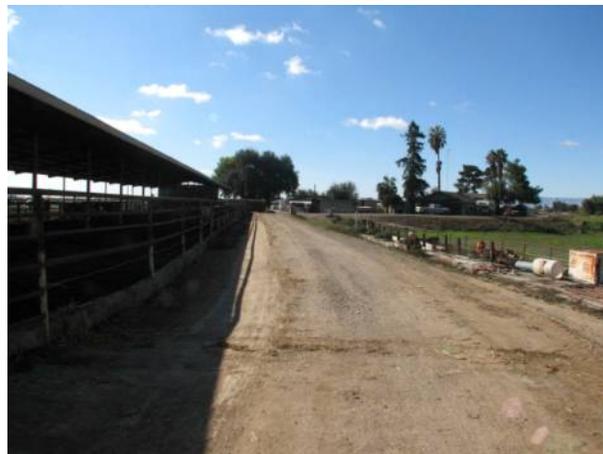
Levee Mile Report Line	12
Start Levee Mile	0.55
End Levee Mile	0.65
Location	Land Side
Category	Earthen Levee
Item	Encroachments
Fall 2009 photo of livestock pens and house on landside slope.	
mkhashch_f_20120927_064.jpg

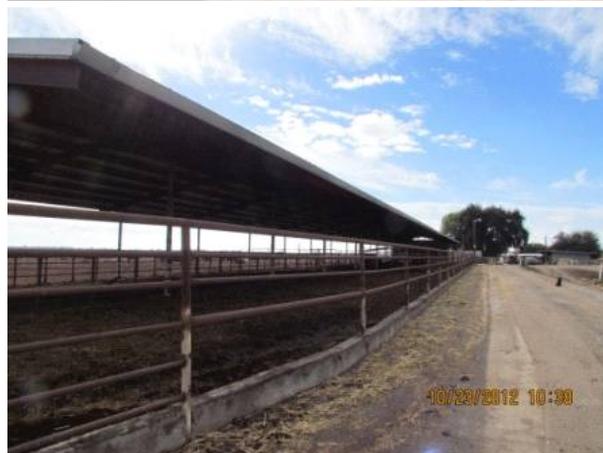
Levee Mile Report Line	12
Start Levee Mile	0.55
End Levee Mile	0.65
Location	Land Side
Category	Earthen Levee
Item	Encroachments
Fall 2012 photo of livestock pens and house on landside slope.	
mkhashch_f_20121029_691.JPG

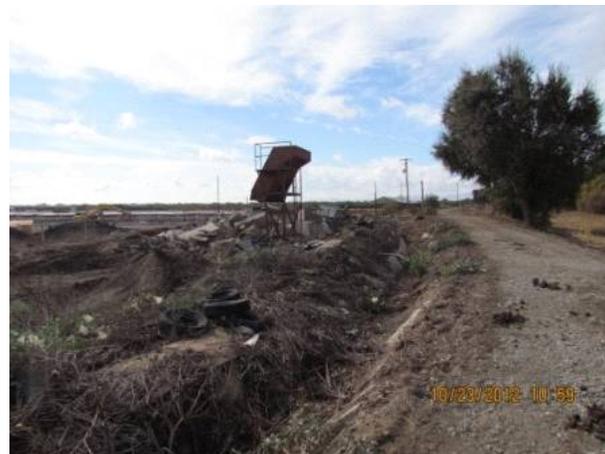
Levee Mile Report Line	19
Start Levee Mile	0.75
End Levee Mile	0.78
Location	Land Side
Category	Earthen Levee
Item	Encroachments
View of the ditch on landside levee toe, facing downstream.	
mkhashch_f_20121029_695.JPG

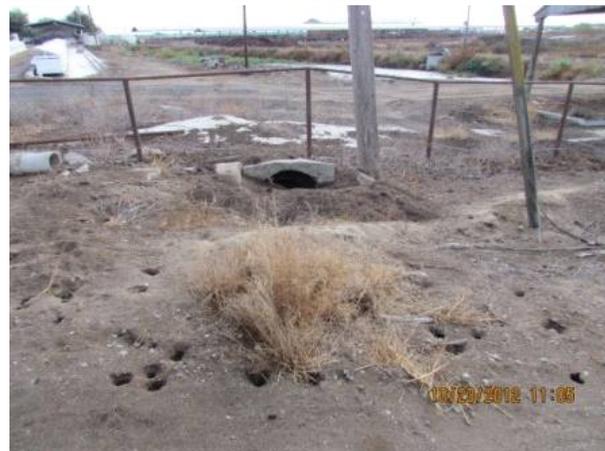
Levee Mile Report Line	20
Start Levee Mile	0.78
End Levee Mile	0.78
Location	Land Side
Category	Earthen Levee
Item	Animal Control
View of rodent burrows on landside slope.	
mkhashch_f_20121029_696.JPG

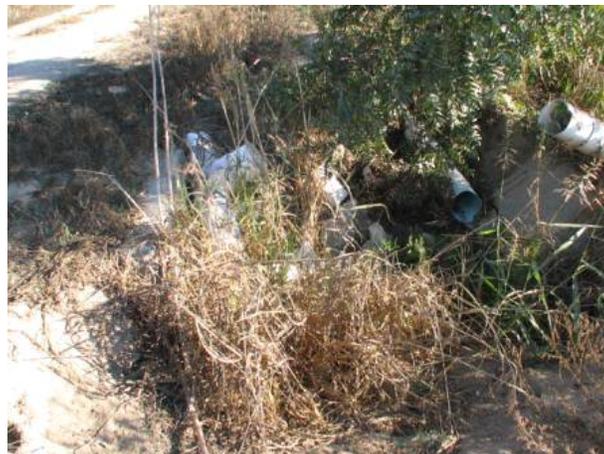
Levee Mile Report Line	21
Start Levee Mile	0.81
End Levee Mile	0.81
Location	Land Side
Category	Earthen Levee
Item	Encroachments
10/26/2011 Updated photo of PVC pipe pieces obstructing drain pipe, issue remains from Spring 2011 inspection.	
mkhashch_f_20120927_057.jpg

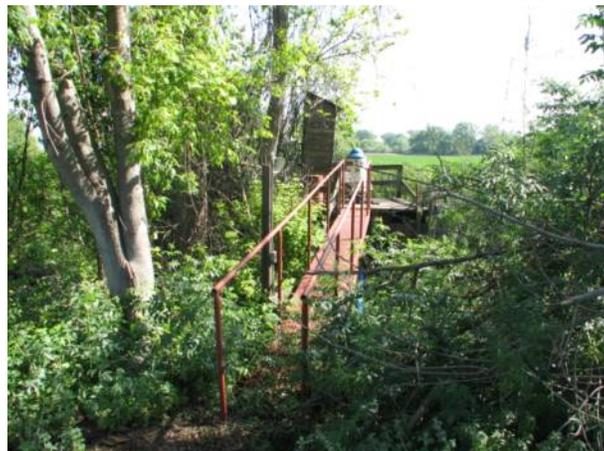
Levee Mile Report Line	23
Start Levee Mile	1.27
End Levee Mile	1.27
Location	Water Side
Category	Earthen Levee
Item	Encroachments
Irrigation intake pump and pipe.	
mkhashch_f_20120927_054.jpg

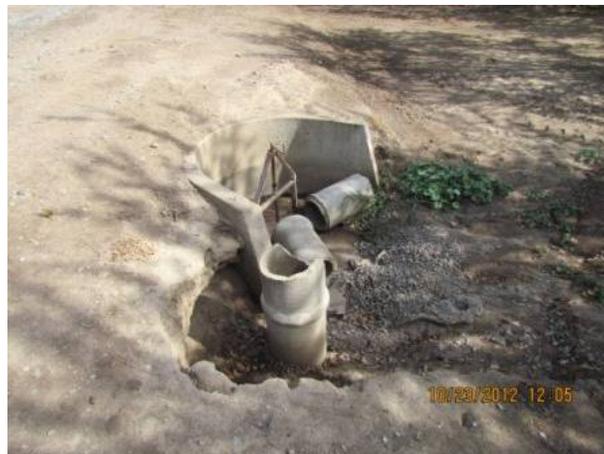
Levee Mile Report Line	24
Start Levee Mile	1.58
End Levee Mile	1.58
Location	Land Side
Category	Earthen Levee
Item	Erosion / Bank Caving
View of the erosion site on landside slope, facing upstream.	
mkhashch_f_20121029_697.JPG

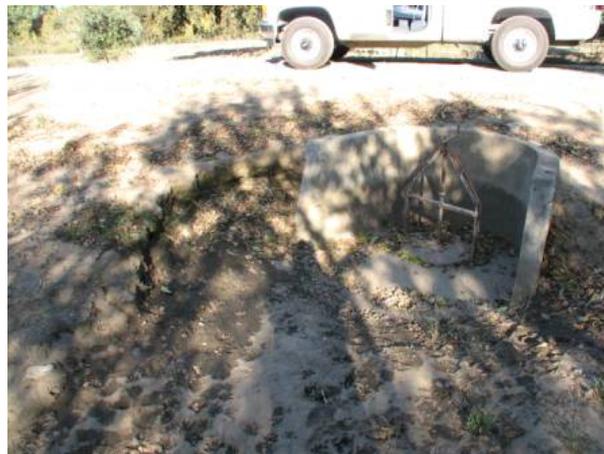
Levee Mile Report Line	25
Start Levee Mile	1.60
End Levee Mile	1.60
Location	Water Side
Category	Earthen Levee
Item	Erosion / Bank Caving
10/26/2011 Active erosion shown around irrigation inlet.	
mkhashch_f_20120927_052.jpg

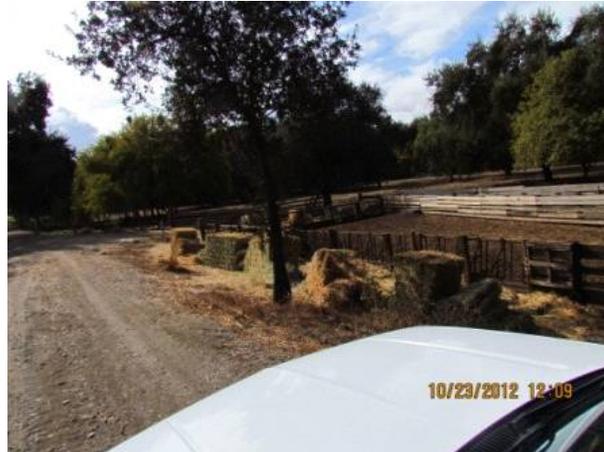
Levee Mile Report Line	27
Start Levee Mile	1.88
End Levee Mile	1.88
Location	Water Side
Category	Earthen Levee
Item	Encroachments
View of hay bales at toe of levee on waterward side, facing downstream.	
mkhashch_f_20121029_698.JPG

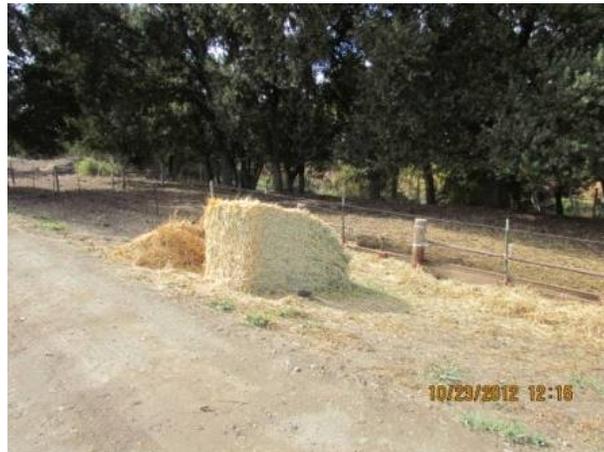
Levee Mile Report Line	29
Start Levee Mile	2.17
End Levee Mile	2.17
Location	Water Side
Category	Earthen Levee
Item	Encroachments
View of hay bales at toe of levee on waterward side, facing downstream. 05/02/2012	
mkhashch_f_20121029_699.JPG

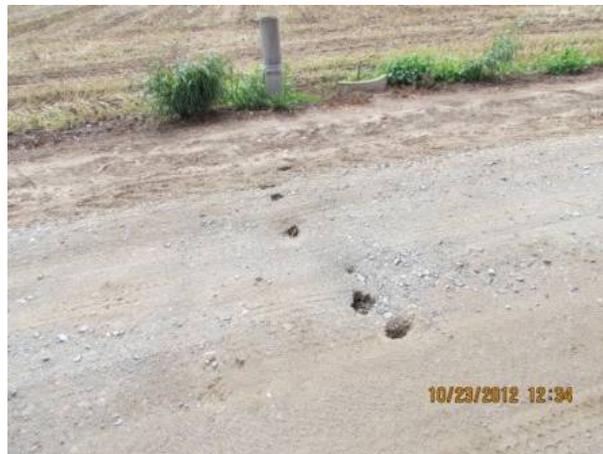
Levee Mile Report Line	33
Start Levee Mile	2.56
End Levee Mile	2.56
Location	Crown
Category	Earthen Levee
Item	Animal Control
View of the several rodent holes in levee crown.	
mkhashch_f_20121029_704.JPG

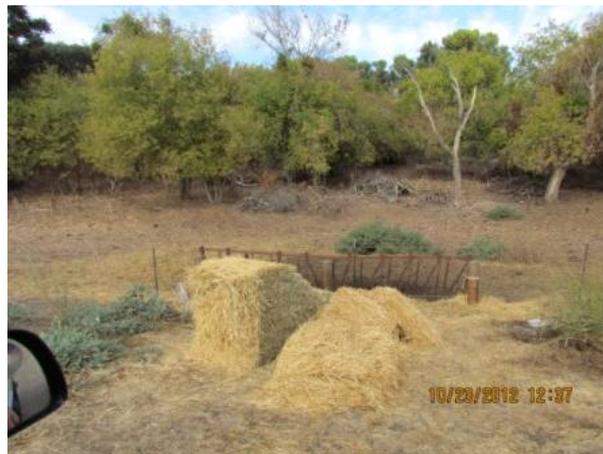
Levee Mile Report Line	34
Start Levee Mile	2.66
End Levee Mile	2.66
Location	Water Side
Category	Earthen Levee
Item	Encroachments
View of hay bales at toe of levee on waterward side, facing downstream.	
mkhashch_f_20121029_705.JPG

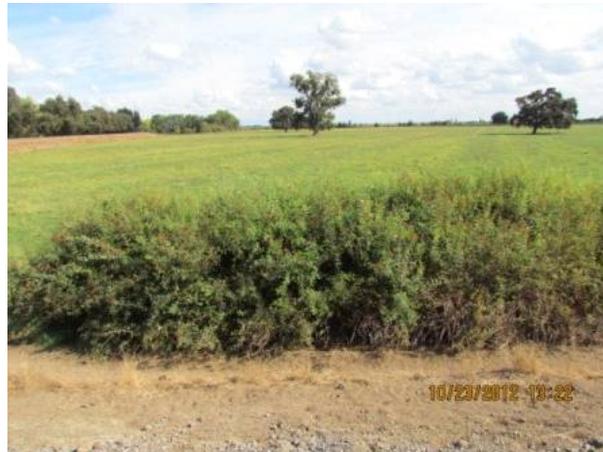
Levee Mile Report Line	47
Start Levee Mile	5.35
End Levee Mile	5.35
Location	Water Side
Category	Earthen Levee
Item	Vegetation
View of the wild rose at landside levee toe obstructing visibility and access.	
mkhashch_f_20121029_706.JPG

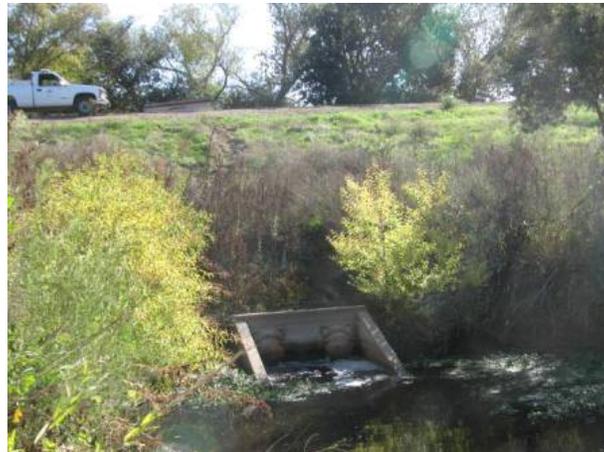
Levee Mile Report Line	1
Start Levee Mile	0.22
End Levee Mile	0.22
Location	Land Side
Category	Earthen Levee
Item	Encroachments
10/26/2011 Flap gates on landside.	
mkhashch_f_20120927_071.jpg

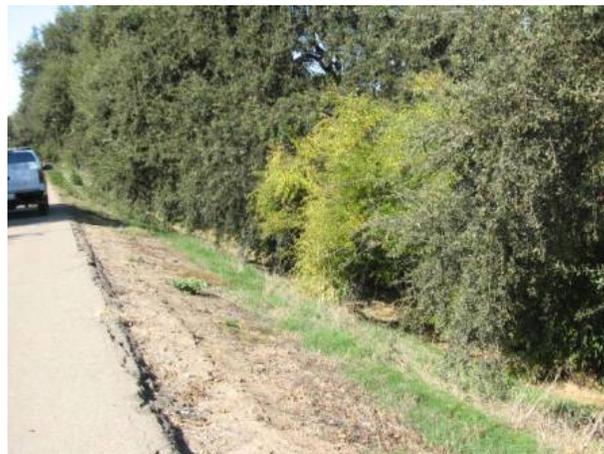
Levee Mile Report Line	2
Start Levee Mile	0.63
End Levee Mile	0.63
Location	Land Side
Category	Earthen Levee
Item	Trim / Thin Trees
10/26/2011 Trees on landside need to be trimmed up 5' above the ground to allow for visibility of the landside slope and toe.	
mkhashch_f_20120927_075.jpg

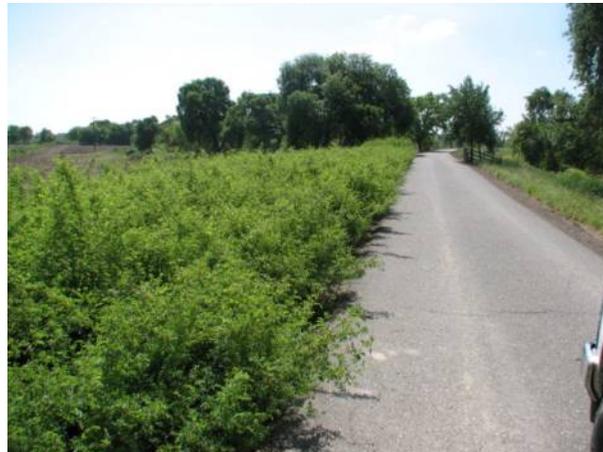
Levee Mile Report Line	4
Start Levee Mile	1.45
End Levee Mile	1.47
Location	Land Side
Category	Earthen Levee
Item	Vegetation
Wild rose on levee slope.	
mkhashch_f_20120927_093.jpg

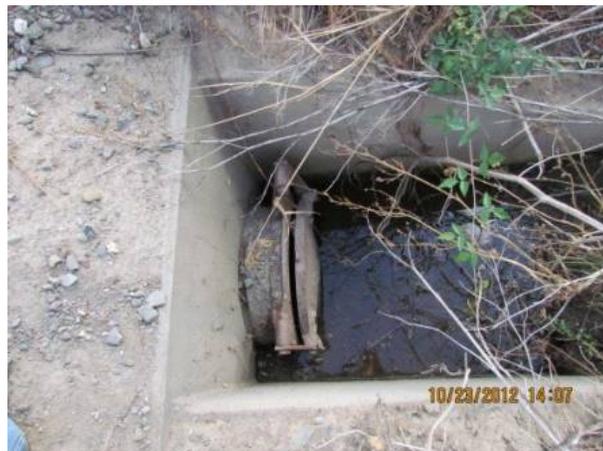
Levee Mile Report Line	6
Start Levee Mile	3.88
End Levee Mile	3.88
Location	Water Side
Category	Earthen Levee
Item	Encroachments
View of flap gate partially open.	
mkhashch_f_20121105_707.JPG

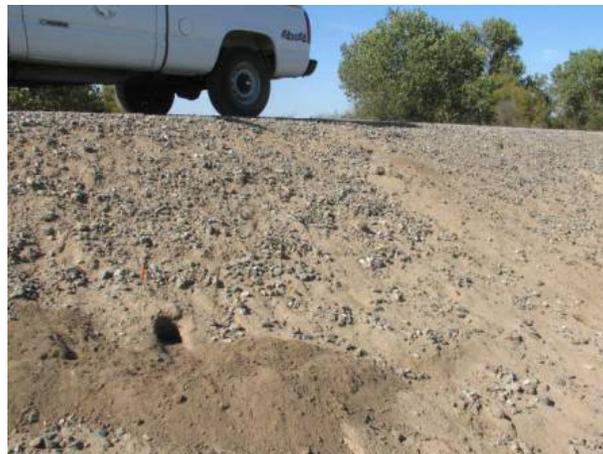
Levee Mile Report Line	8
Start Levee Mile	4.23
End Levee Mile	4.23
Location	Land Side
Category	Earthen Levee
Item	Animal Control
10/26/2011 Typical, burrow in area, several burrows at this location, many of them were flagged prior to the Spring 2011 inspection.	
mkhashch_f_20120927_074.jpg

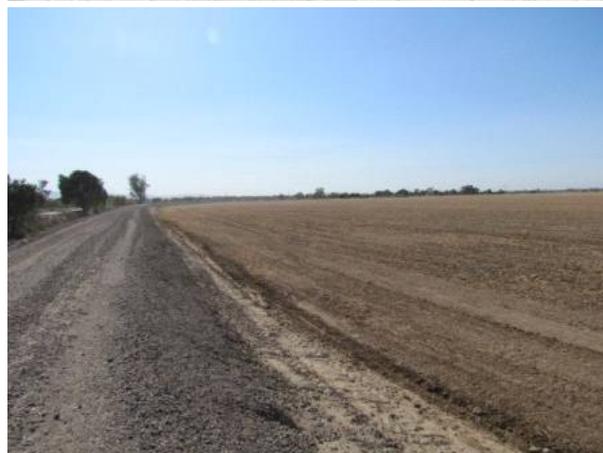
Levee Mile Report Line	9
Start Levee Mile	4.23
End Levee Mile	4.73
Location	Land Side
Category	Earthen Levee
Item	Encroachments
View of agricultural tilling up to landside toe looking west from LM 4.47. 05/24/2012	
mkhashch_f_20120927_092.jpg

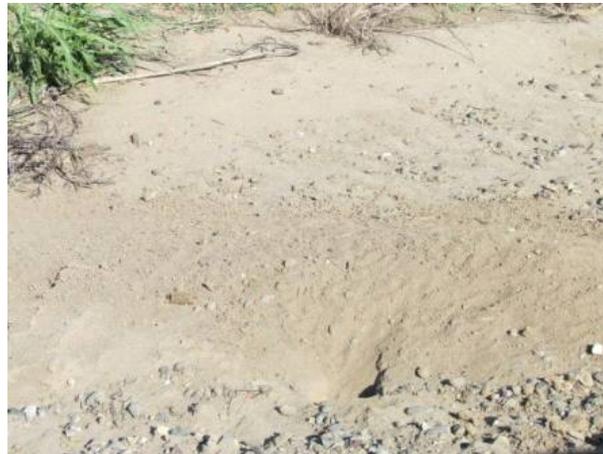
Levee Mile Report Line	10
Start Levee Mile	4.28
End Levee Mile	4.36
Location	Land Side
Category	Earthen Levee
Item	Animal Control
View of active borrow hole at landside toe. 05/24/2012	
mkhashch_f_20120927_077.jpg

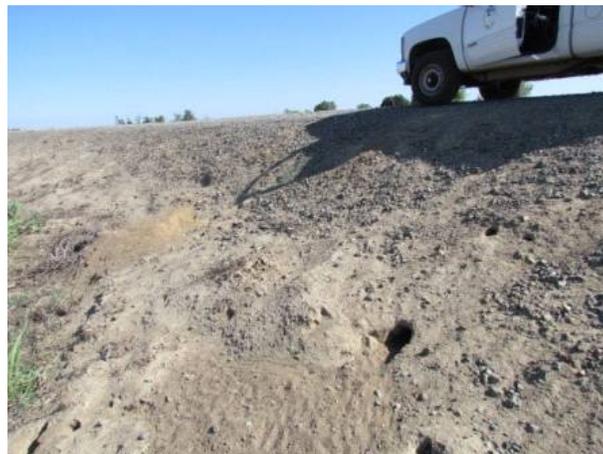
Levee Mile Report Line	10
Start Levee Mile	4.28
End Levee Mile	4.36
Location	Land Side
Category	Earthen Levee
Item	Animal Control
View of several active burrow holes at landside toe. 05/24/2012	
mkhashch_f_20120927_078.jpg

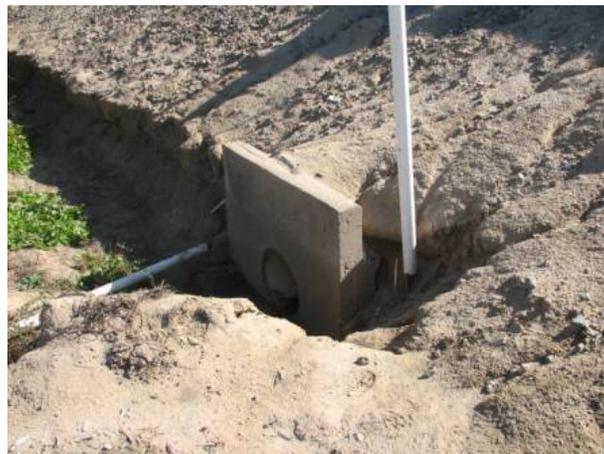
Levee Mile Report Line	15
Start Levee Mile	4.75
End Levee Mile	4.75
Location	Land Side
Category	Earthen Levee
Item	Encroachments
10/26/2011 Photo shows landside of 14" PVC pipe through levee. No flap gate or closure device observed.	
mkhashch_f_20120927_079.jpg

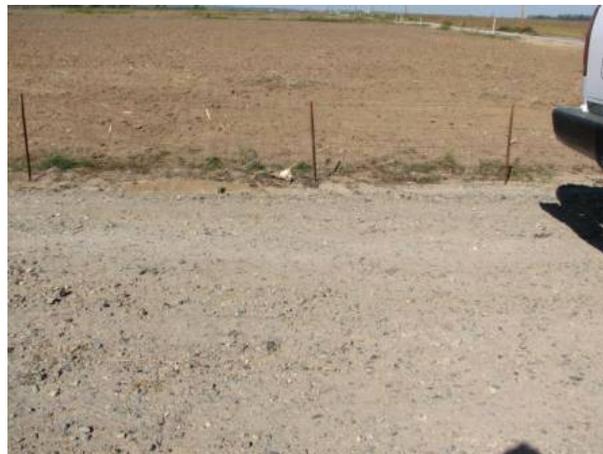
Levee Mile Report Line	17
Start Levee Mile	5.33
End Levee Mile	5.33
Location	Land Side
Category	Earthen Levee
Item	Animal Control
10/26/2011 Photo taken from location of waterside burrow to show relationship to landside burrow, which can be noted by fresh material seen over the levee crown approximately 2' to the left in this photo.	
mkhashch_f_20120927_082.jpg

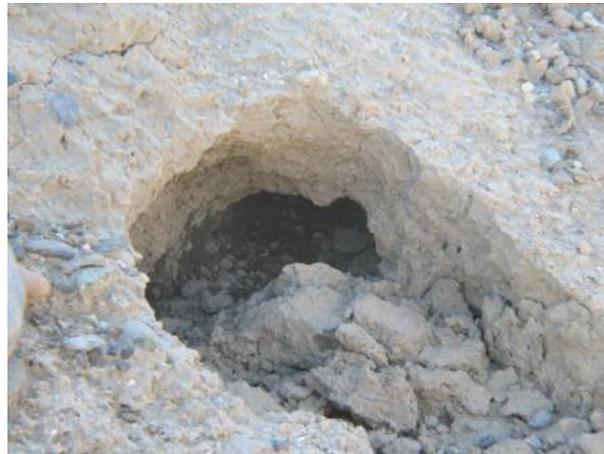
Levee Mile Report Line	21
Start Levee Mile	5.65
End Levee Mile	5.65
Location	Land Side
Category	Earthen Levee
Item	Erosion / Bank Caving
10/23/2011 Erosion located on the landside of the levee. Cracking above the hole in the levee slope and hole extends into the levee prism.	
mkhashch_f_20120927_088.jpg
